Problem
Control cabinet appears to have no power (does not enter cooling down when switched on)

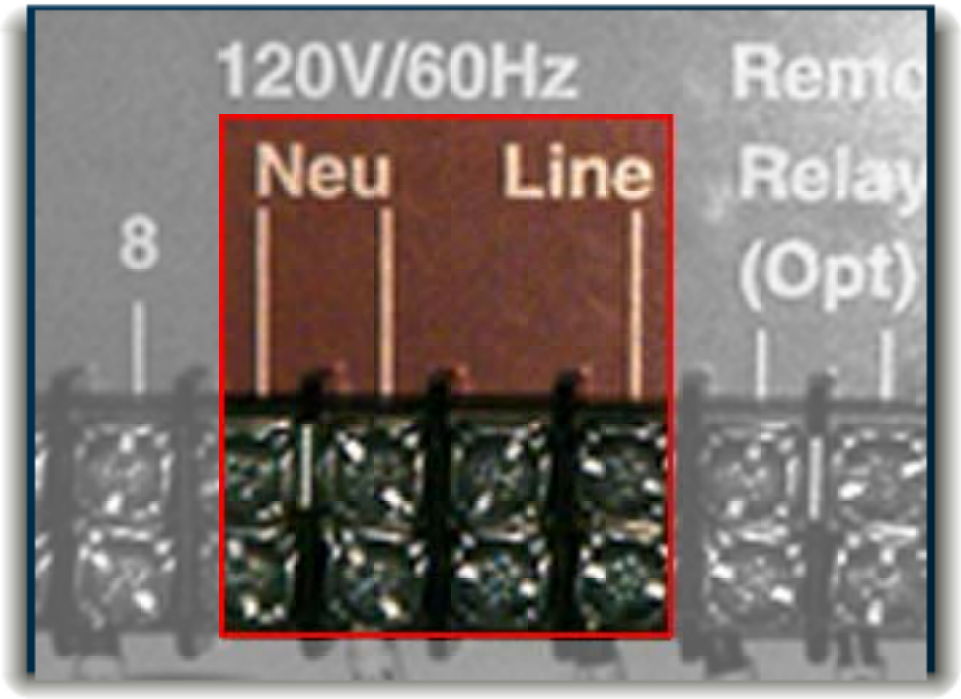
REASON 1
No power to the purger.
SYMPTOM
The ON and PURGER COOLING DOWN lights are not illuminated.
CHECK
The LINE and NEUTRAL terminals inside the control cabinet should have 115V (230V for 230V purger) across
